Eliminating Obsolescence for the C-5 Galaxy Cargo Door & Ramp System Trainer

Refurbishing trainers for use through 2040. The U.S. Air Force is now completing a \$22+ million upgrade to its fleet of C-5 Galaxy heavy lift aircraft. This will keep the fleet in service for the next 40 years. One of the aircraft's 22 critical systems, the Fore and Aft Cargo Door and Ramp systems are supported by three trainers—one each at Travis AFB, California, Dover AFB, Delaware and Lackland AFB, Texas.

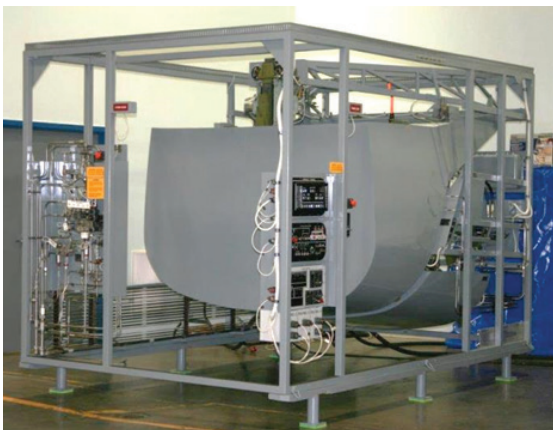
Trainer Forward Loading Panel (Panel 1) includes the Left Hand Forward Loadmaster Control Panel, Flight Station Control Panels, Associated Circuit Breaker Panels and the Air Delivery System.

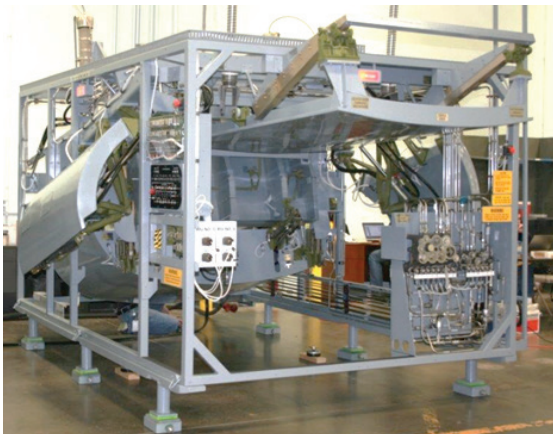
Trainer Aft Loading Panel (Panel 2) includes the Left hand Loadmaster Control Panel, Aft Control Panel and side door. Panel 3 (bottom right corner) provides the necessary hydraulic power to Panels 1 and 2.

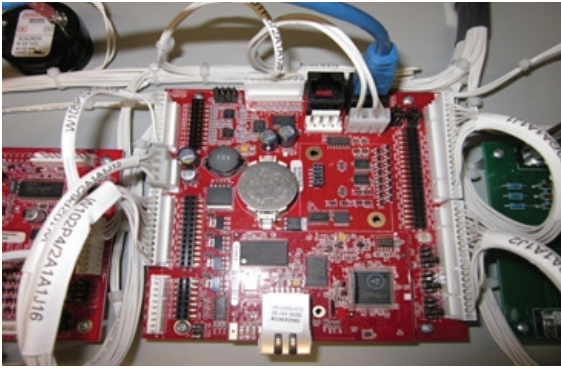
A single board computer was added to control the sequence of the 24 new annunciators so that they are congruent with the aircraft.

- 24 additional annunciator lights.
- A single board computer to control added annunciator lights.
- 6 added malfunctions to Instructor panel for a total of 16.
- Added Remote Interface Unit (RIU) and new pressure door on Panel 2.

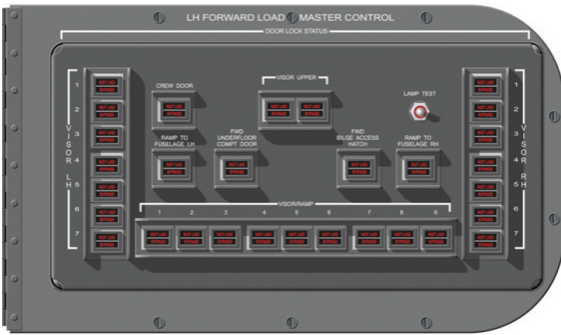
24 additional annunciator lights are added to the Lackland trainer's LH Forward Loadmaster Control Panel. Other control panels upgraded with correct circuit breakers, switches, T-Handles, dimmer knobs and graphics.

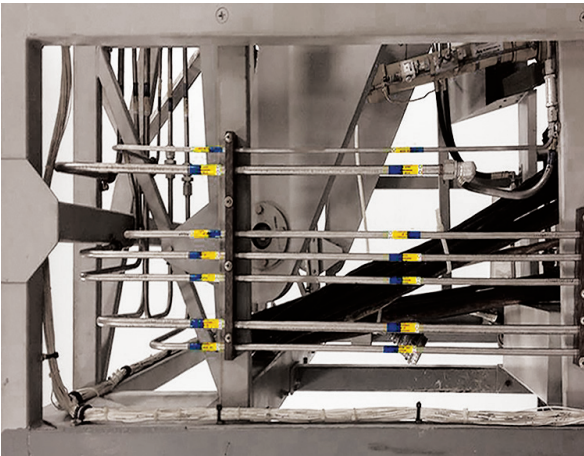
All trainer hydraulic lines and electric wiring are refurbished and marked with laser wire identifiers to facilitate troubleshooting.

- Refurbished hydraulic lines and pump, electric wiring and fiberglass of doors and ramps.
- Replaced bad or leaking actuators.
- All new circuit breakers, buttons and panel graphics on Student Station.
- Media blast and painting of frames and all components.
- New non-movable stand for trainers to sit on while in use.
- All electrical and wire diagrams upgraded to current configuration.
